Manhole Inspection Summary

Manhole # S09Y__005MH

Insp Date: **4/22/08 1:42 PM**

Location Address: **1229 Pine Heights**

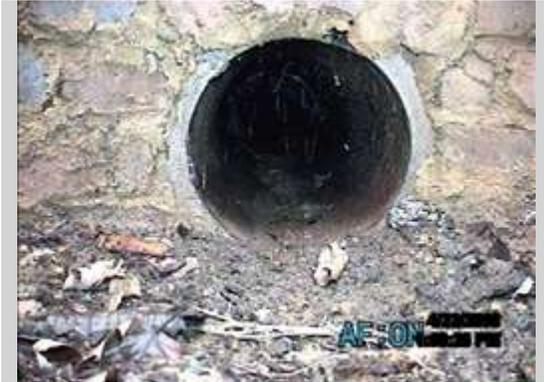
12 O'Clock Outflow

8 in. Circular Gravity Sewer
Pipe Out @ 12 O'Clock

Pipe Height: **8.4** (in.) Rod and Bar (Angled)

Pipe Material: **Clay** Pipe Lined

Infiltration: **None** Pipe Seal Cond: **Sound**
